Failure Modes And Prognostic Techniques For H-60 Tail Rotor Drive System Bearings

Clint Baker, Sean Marble, Brogan P. Morton
Sentient Corporation
850 Energy Dr.
Idaho Falls, ID 83401
208-522-8560
cbaker@sentientscience.com

Abstract—The failure modes and diagnostic/prognostic signatures for the oil cooler and hanger bearings used in the tail rotor drive system of the H-60 series of helicopters are being researched. The overall goal is to develop a prognosis system to track and predict bearing degradation and to integrate those technologies with the open architecture IMD-HUMS. This paper summarizes the challenges and advancements that have been experienced while improving the diagnostic capabilities for the bearings. The causes and effects of bearing contamination and lubricant exhaustion are addressed, while the focus is placed on detection methods of these failure modes. Interesting and encouraging results were found for both the oil cooler bearings and the hanger bearings, but at the present time, the potential is greatest for the development of detection methods and PHM algorithms for oil cooler bearings. The anticipated system will enable fault diagnosis, damage tracking, and

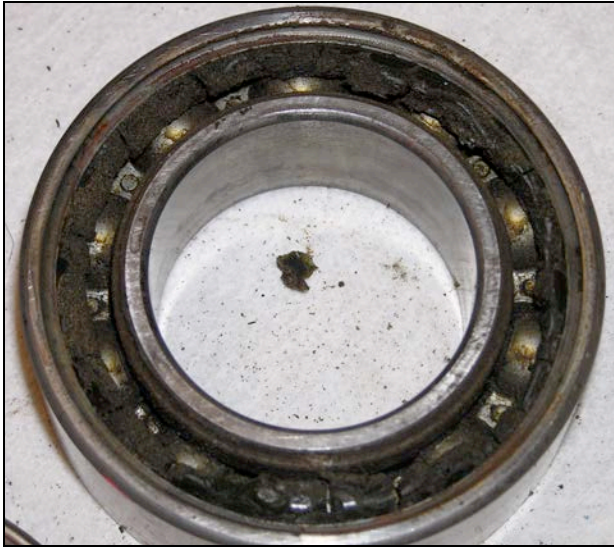
Figure 2: Debris-filled oil cooler bearing

The oil cooler bearings support a fan that draws in ambient air and forces it through an oil-cooling radiator. Unavoidably, the incoming air carries contaminants such as dust, dirt, sand, water, and bits of vegetation through the system. For the most part, this is of little consequence because the air is immediately expelled after it passes through the radiator. The oil cooler bearings, however, are exposed to the flow of contamination. The bearings are shielded to minimize ingestion, but an air gap between the shield and inner race allows some of the smaller particles to enter the bearing. Figure 2 is a photograph of an oil cooler bearing (shields removed) that has taken in a large quantity of debris during normal service. The debris has been thoroughly mixed with the grease, which severely inhibits the effectiveness of lubrication. The rolling elements run over the debris and form indentations in the bearing raceways. Both the action of over-rolling and the resulting raceway damage increase vibration levels. In general, the added energy is broadband and does not create a specific fault frequency.

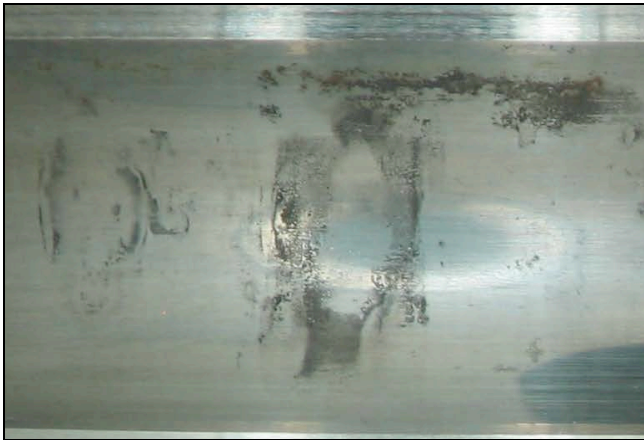
Figure 3: Oxidation of oil cooler bearing inner raceway

only to particle contamination in its damaging capabilities. Water is known to promote oil oxidation, attack rust inhibitors, and impede the formation of a load carrying elastohydrodynamic lubrication (EHL) film [1]. Additionally, corrosion by oxidation commonly occurs in contact regions between rolling elements and raceways when the bearings are idle. Evidence of this phenomenon is clearly illustrated by the black surfaces on the inner raceway of a retired bearing in Figure 3. These damaged areas are likely sites for spall initiation in the future [2]. In the condition shown here, the raceway has lost a negligible amount of material, but the surface is noticeably rougher.

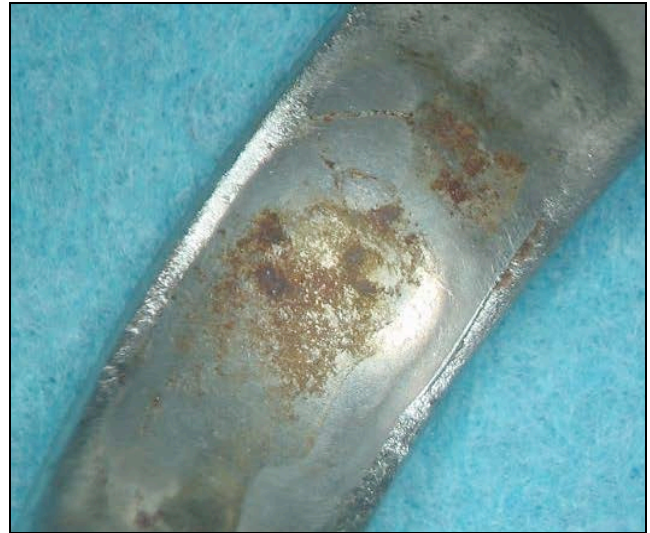
Figure 4: Corroded inner surface of the cage in the ball/cage contact region

The ball retainer, or cage, often receives the least amount of attention in the design and engineering of bearings because it is not a load-bearing element. As a result, its material may be less resistant to corrosion. This is indeed the case in the oil cooler bearings. Figure 4 shows the obvious rust that has formed on the inner surface of the cage in the contact region between the cage and the ball. The geometry of the cage forms a pocket that is capable of trapping water and promoting corrosion. The balls are also affected by this corrosion, albeit to a lesser degree. Upon rolling, the damaged surfaces of the balls continuously interact with the cage and the raceways and increase vibration. Corrosion of the cage could also lead to the release of macroscopic

particles from the affected area, further contaminating the grease and likely leading to damage on the raceways.

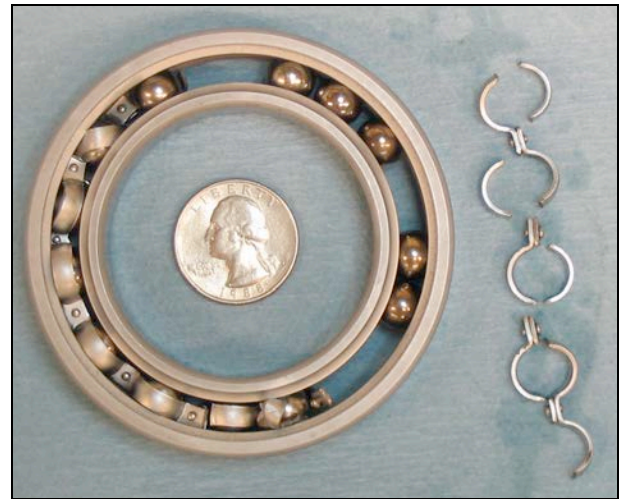
Figure 8: Degreased hanger bearing that seized in a lab test

The primary failure mode of hanger bearings is exhaustion of lubrication. As exemplified by the seized hanger bearing in Figure 8, lack of lubrication failures can be very sudden and dramatic. Except for visible leakage, grease loss is extremely difficult to track, since even a small fraction of the original grease is sufficient for proper bearing operation. Of course, there is a point where insufficient lubrication does begin to affect bearing operation and diagnostic indicators are more easily identifiable. At this point, a vibration signal will typically show an increased RMS, but this approach often does not provide sufficient lead-time before failure. A degreased hanger bearing was intentionally run to failure in a laboratory experiment. The results are shown in Figure 9, where the RMS began to increase only 10-20 minutes before the bearing seized. Similar to the oil cooler bearing application described in Section 2, there are typically no specific frequencies that can be used to identify the faulted state.

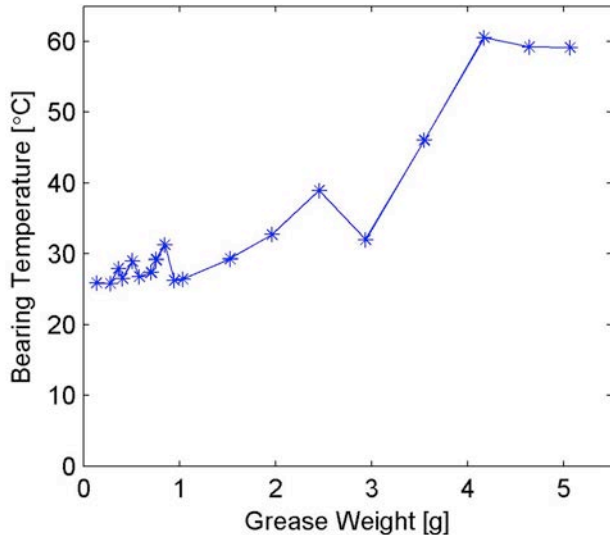
Figure 10: Generally, hanger bearing temperature increases with an increasing quantity of grease

As a general trend, bearing temperature increased with grease level. This relationship is demonstrated in Figure 10. The lowest grease levels consistently resulted in the lowest bearing temperatures. In all tests, the temperature increased drastically between 3 and 4 grams of grease. This is most

likely the upper bound where the grease occupies all of the free volume within the bearing that is not in the swept path of the cage/ball train. Drag, churning, and shearing of grease then generate high friction and temperature until the excess grease can be forced past the seals and out of the bearing.
